Assessment of Dam Safety of Coal Combustion Surface Impoundments

Coletto LP, LLC

Coletto Creek Power, LP

Draft Report

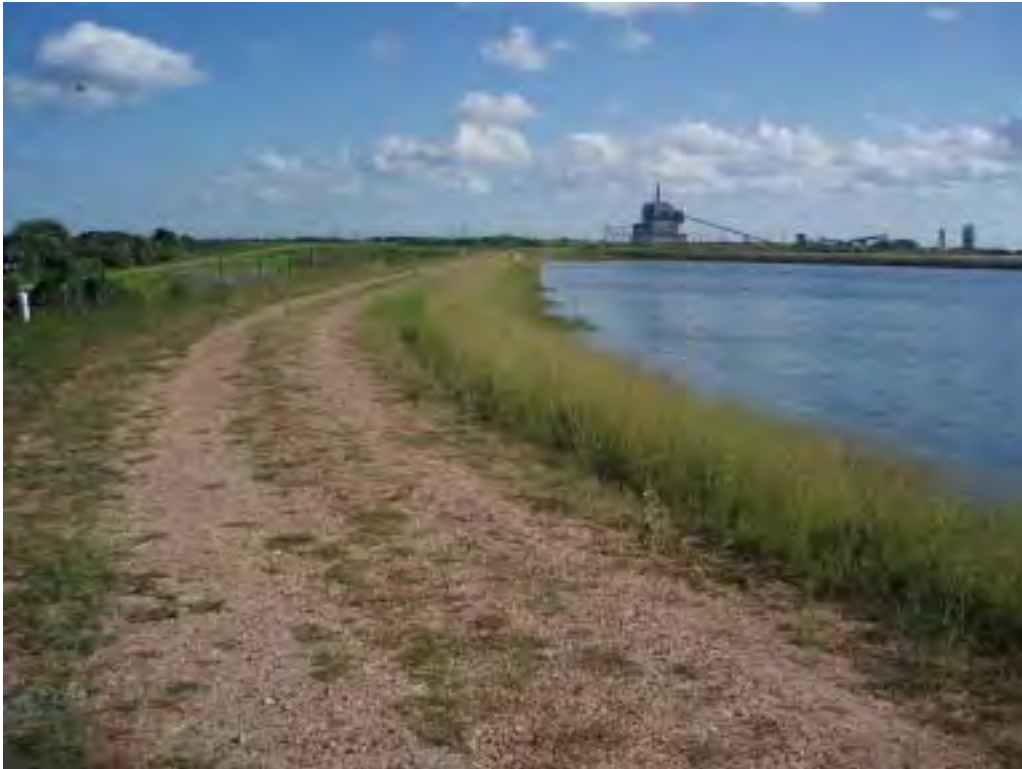
The crest of the Secondary Pond embankments appeared to be generally in fair condition (Photos 2, 14, 17, 41, 46, and 47). The crest was generally approximately 20 feet wide. The crest is surfaced with compacted gravel and is used as an access road. Sparse vegetation was growing in the middle and on both sides of the roadway. A barbed wire fence used to contain livestock was observed on the north and east embankment crest perimeter (Photos 46, 47, and 48). The vertical alignment of the fence posts was in good condition. Observed freeboard at the time of the visit was approximately three feet.

Photo No. 47: Secondary Pond – East embankment interior slope and crest, looking south.

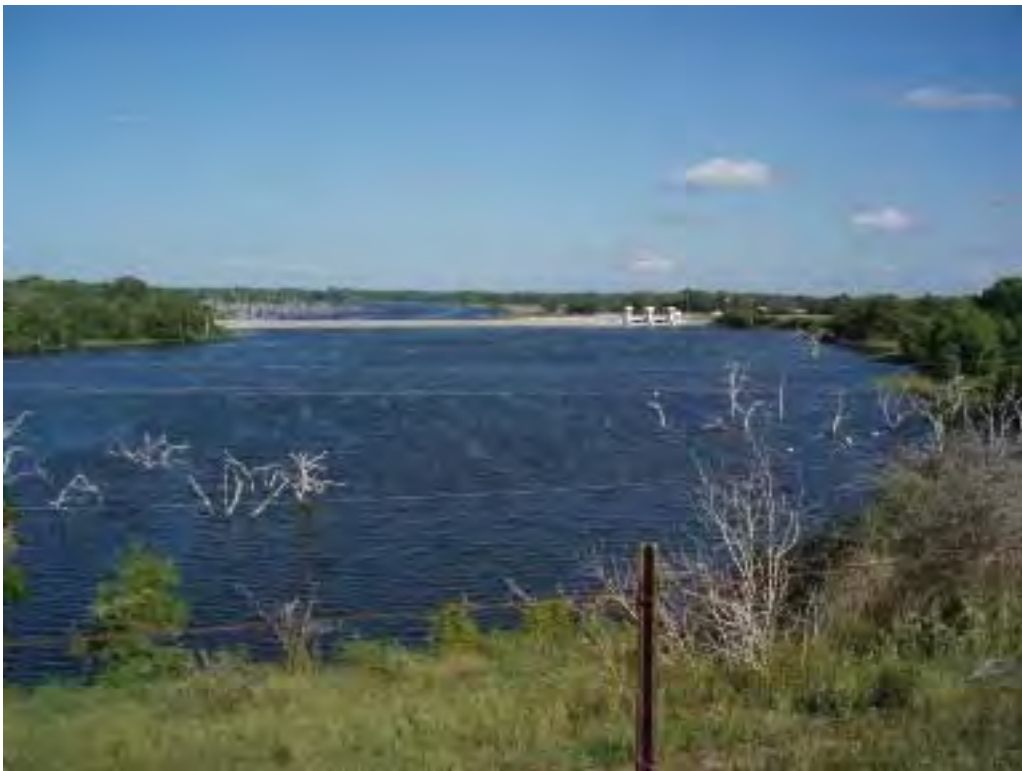
Photo No. 48: Secondary Pond – East embankment, looking east at Coletto Creek Reservoir at toe of embankment.

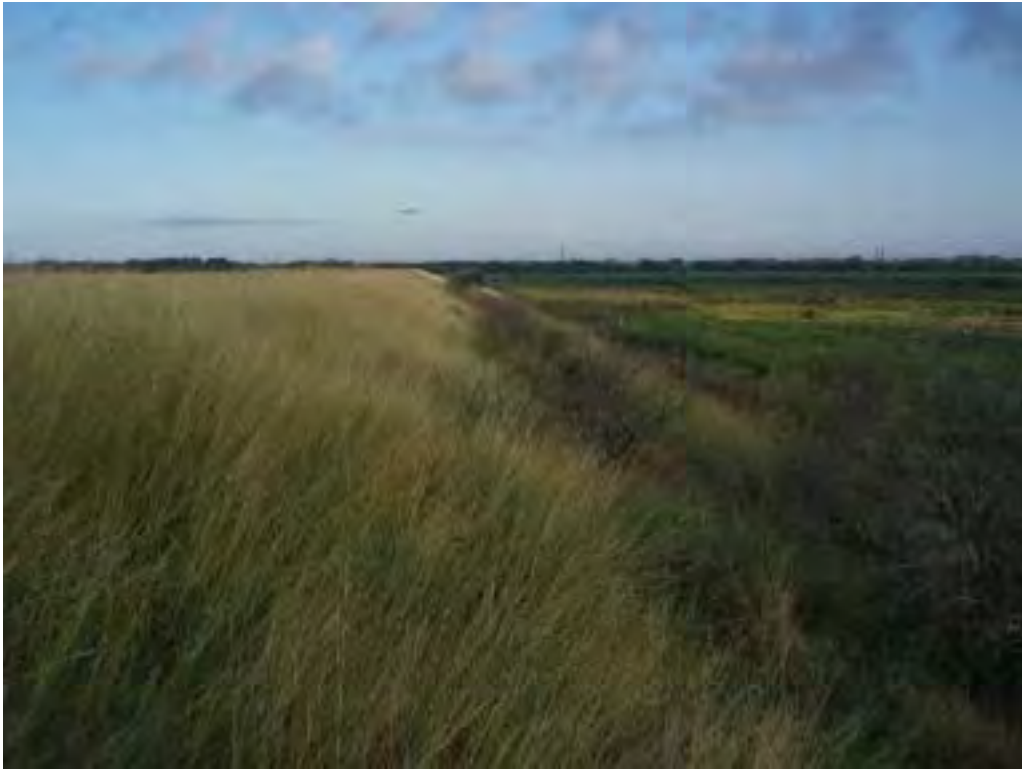
The exterior slopes appear to be in fair condition. The exterior slopes on the north, southern, west, and east embankments were approximately 2.5H:1V (Photos 49, 52, 53, 56, 62, 66, 67, 72, 76, 79, 82, 86, 90, 91, 96, 99, 104, 111, and 114). The northeast slope of the divider embankment between the Primary Ash Pond and Secondary Pond was approximately 3H: 1V (Photos 1 and 15).

Photo No. 49: Primary Ash Pond – North embankment exterior slope, looking west. Note 8- to 12-inch-diameter mesquite trees on slope.

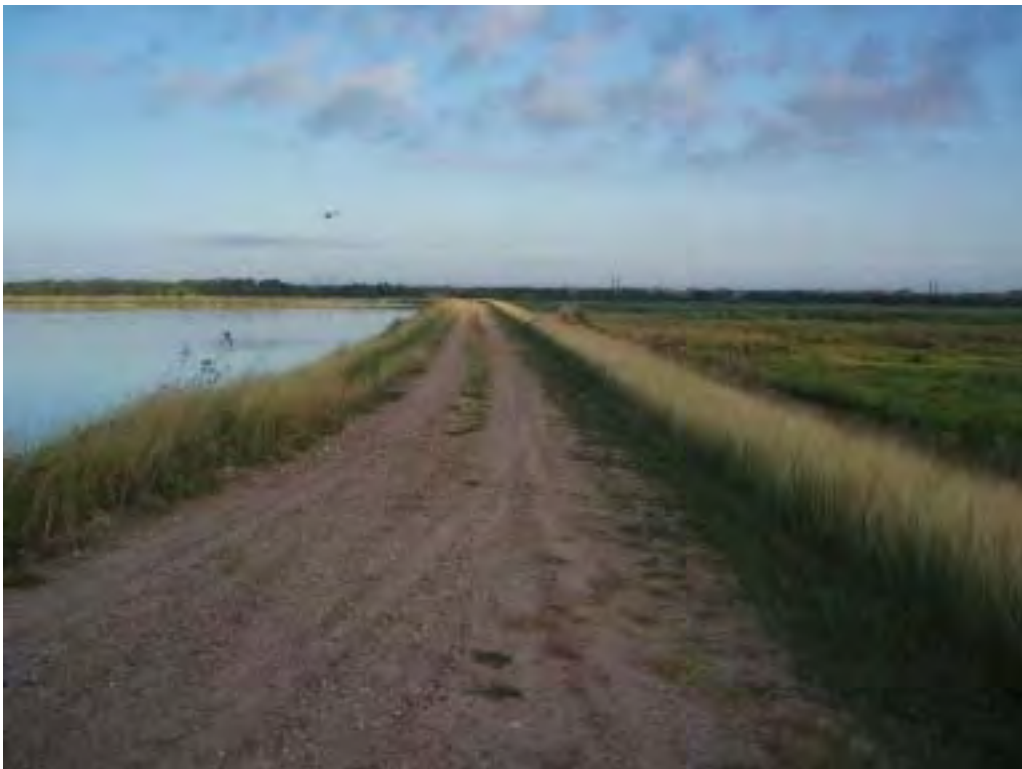
Photo No. 50: Primary Ash Pond – North embankment crest, looking west.

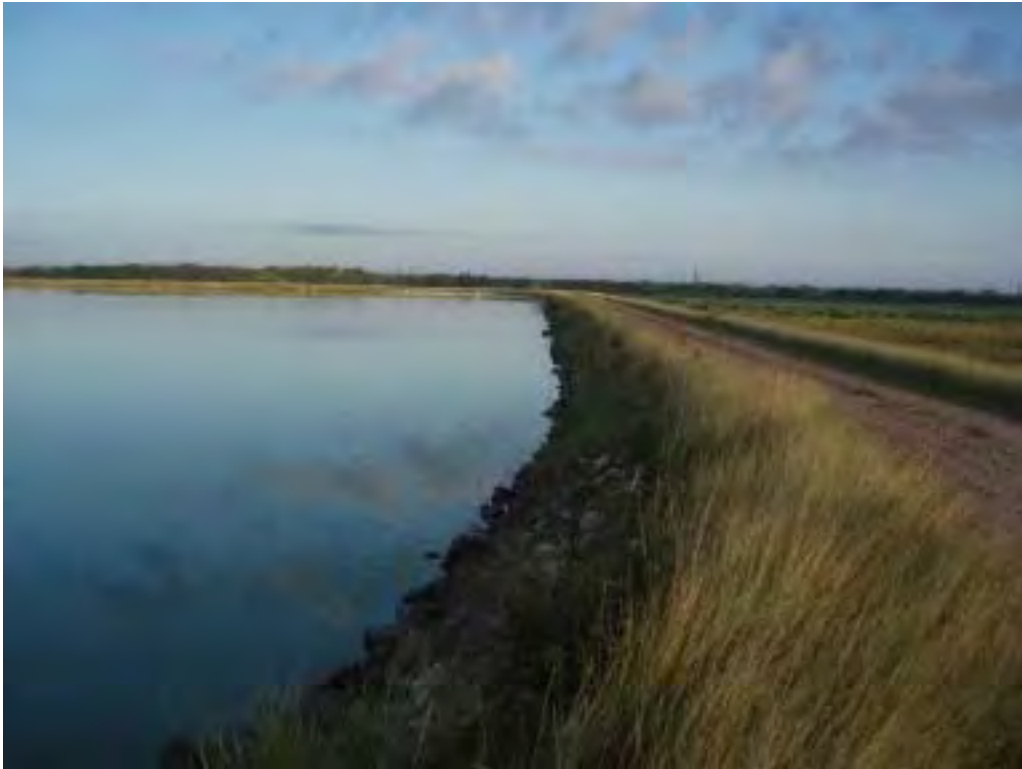
The visible portions of the interior slope generally appeared to be in fair condition (Photos 3, 9, 10, 12, 13, 51, 54, 58, 61, 64, 70, 74, 78, 79, 85, 87, 88, 93, 94, 101, 102, 110, 113, and 116). The north, east, and west interior slope and southwest slope of the divider embankment generally appeared to be armored with a layer of riprap. No riprap was observed on the southern embankments. Grass and brush approximately 24 to 36 inches tall was observed growing in the riprap. An 8-inch-diameter mesquite tree was observed on west end of the north embankment (Photo 54).

Photo No. 51: Primary Ash Pond – North embankment interior slope, looking west.

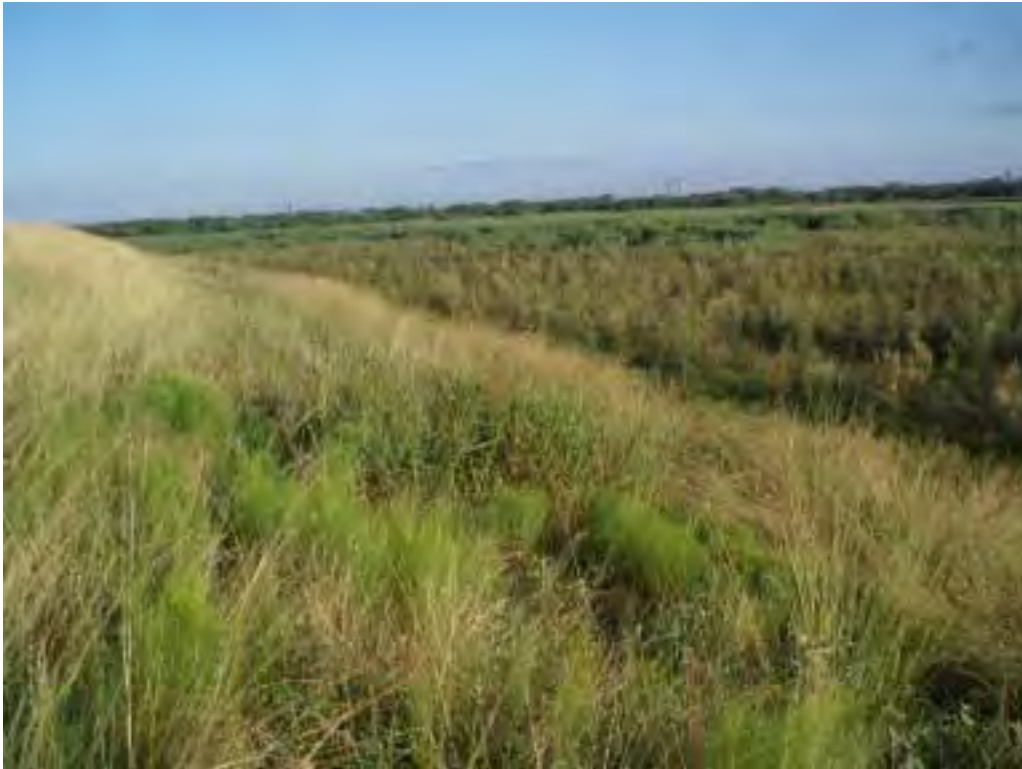
Photo No. 53: Primary Ash Pond – North embankment exterior slope, looking west at lush vegetation.

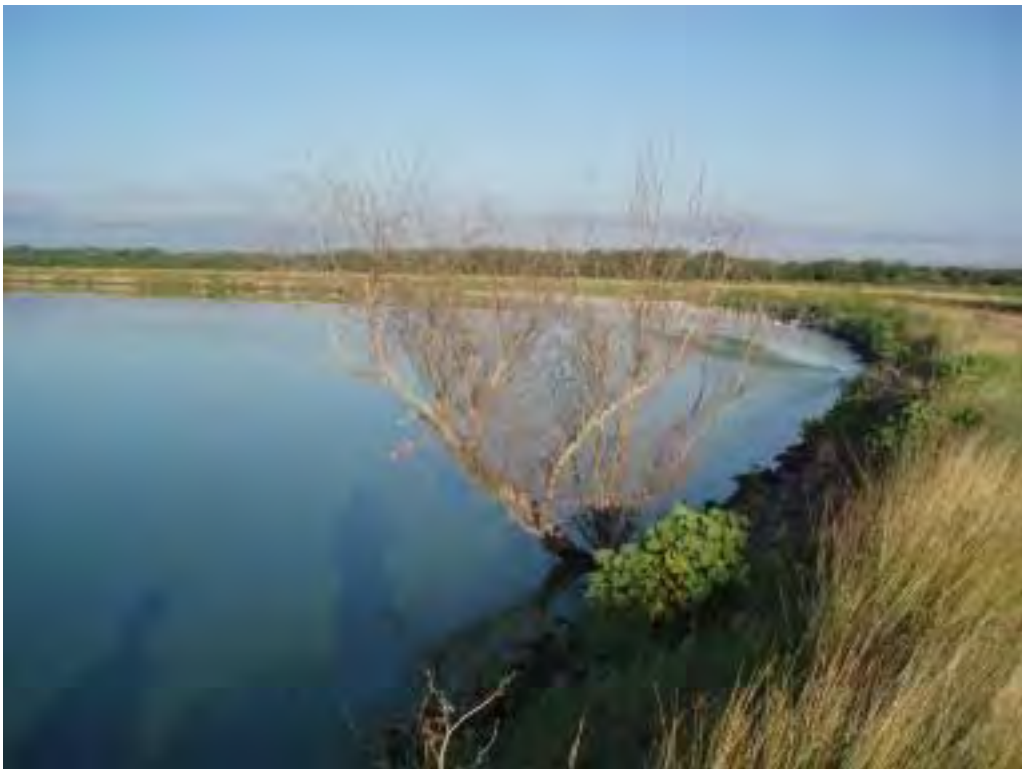
Photo No. 54: Primary Ash Pond – North embankment interior slope, looking west at a dead 8-inch-diameter mesquite tree.

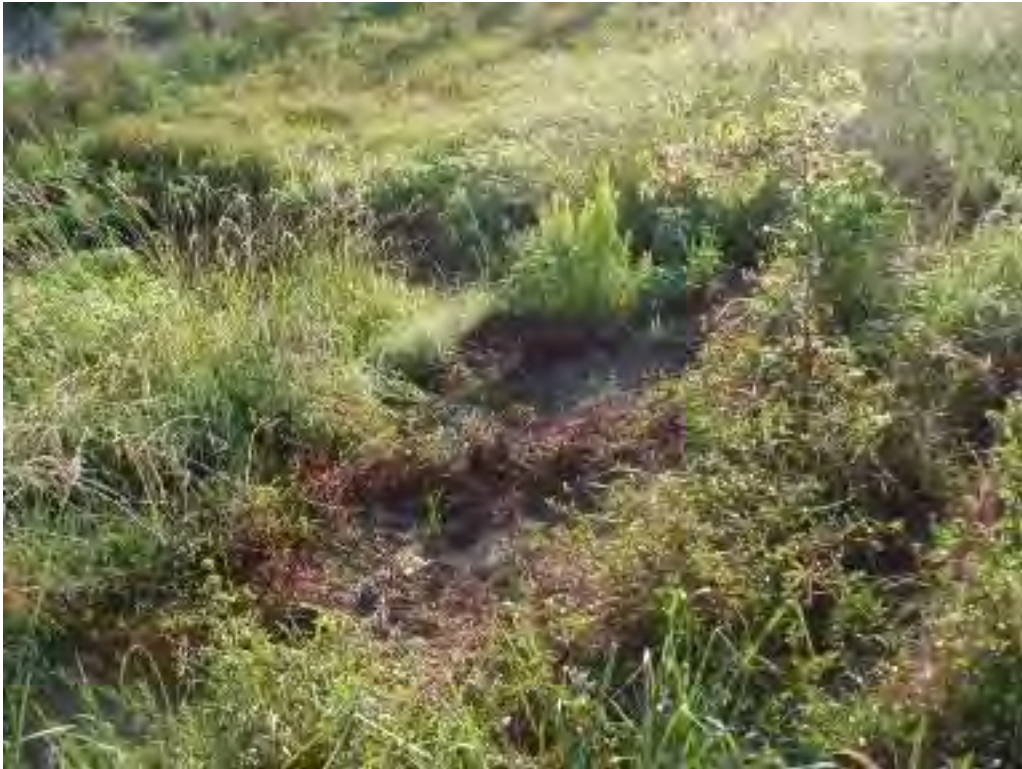
On the north embankment there was some minor surface erosion near the toe adjacent to the evaporation pond (Photo 55). Water was observed adjacent to the west embankment toe in the evaporation pond (Photos 67 and 69).

Photo No. 55: Primary Ash Pond – North embankment exterior slope, looking at surface erosion area.

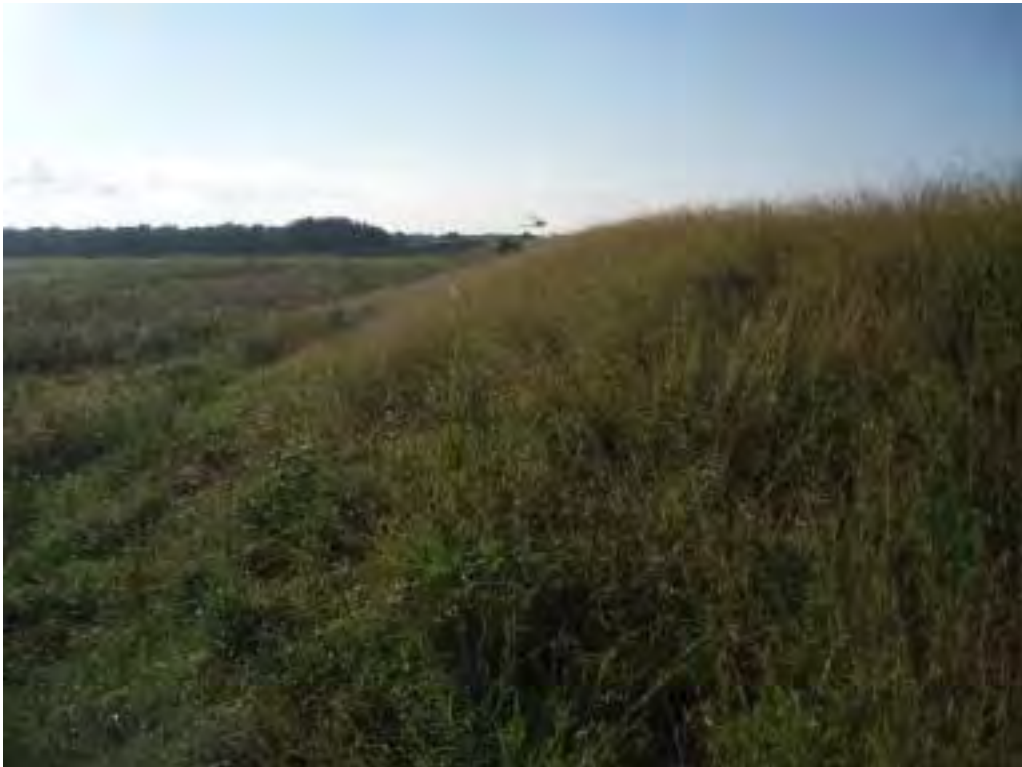
Photo No. 56: Primary Ash Pond – North embankment exterior slope, looking east.

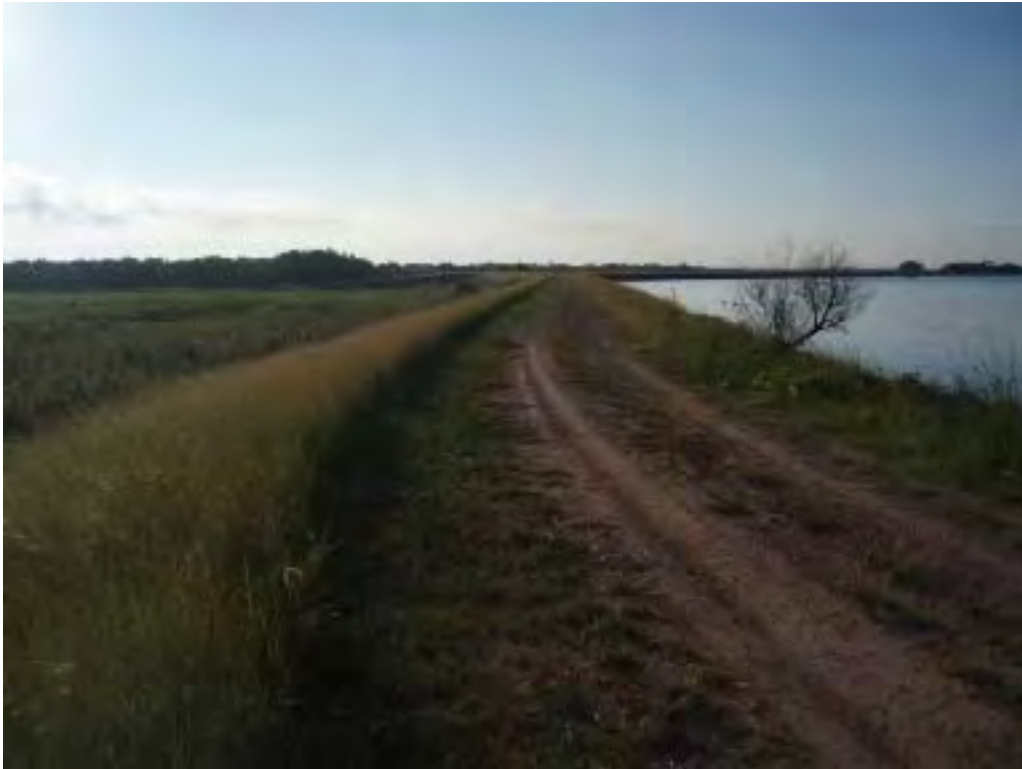
Photo No. 57: Primary Ash Pond – North embankment crest, looking east.

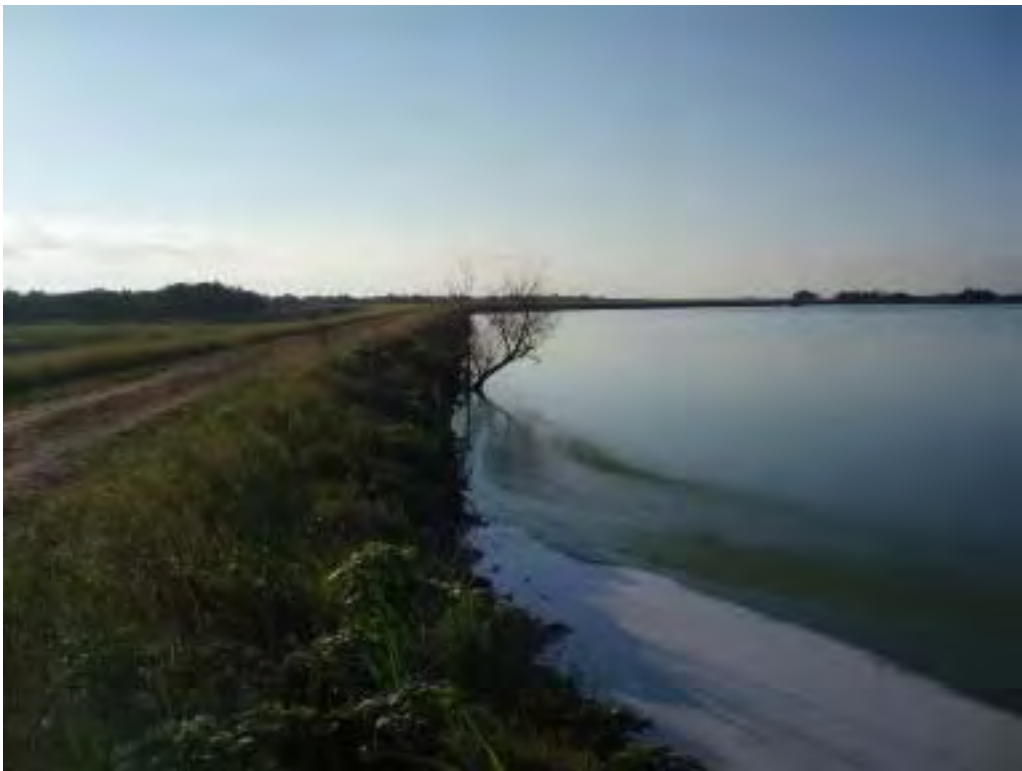
Photo No. 58: Primary Ash Pond – North embankment interior slope, looking east.

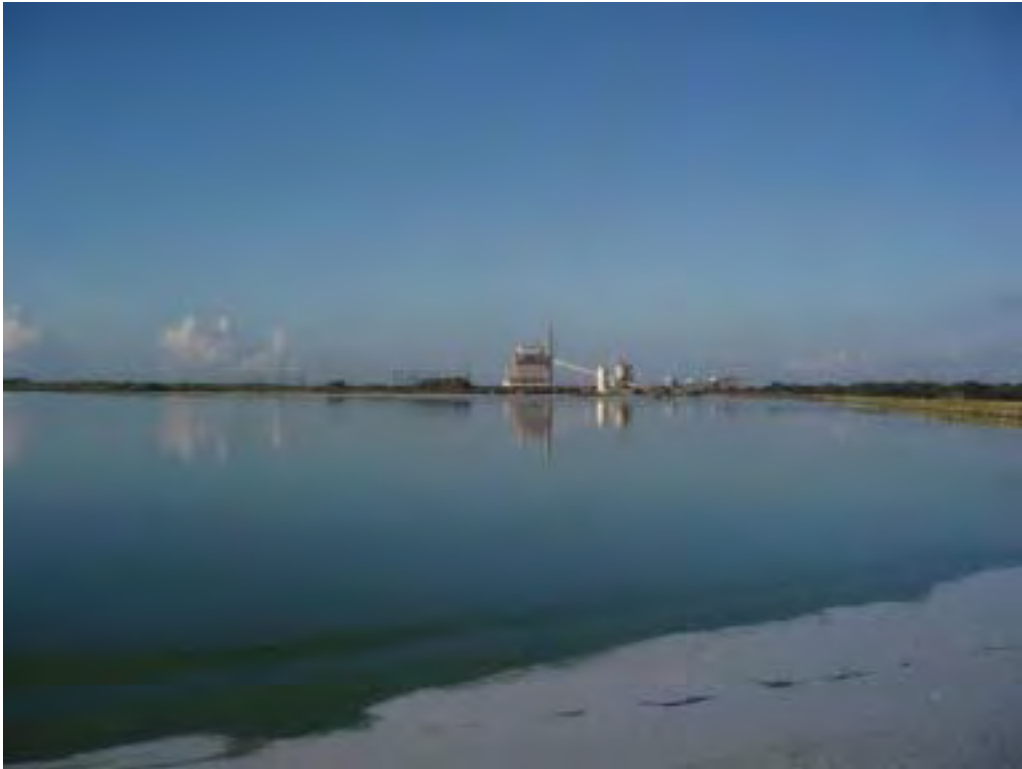
Photo No. 59: Primary Ash Pond – Overview of impoundment of power plant, looking south from the north embankment.

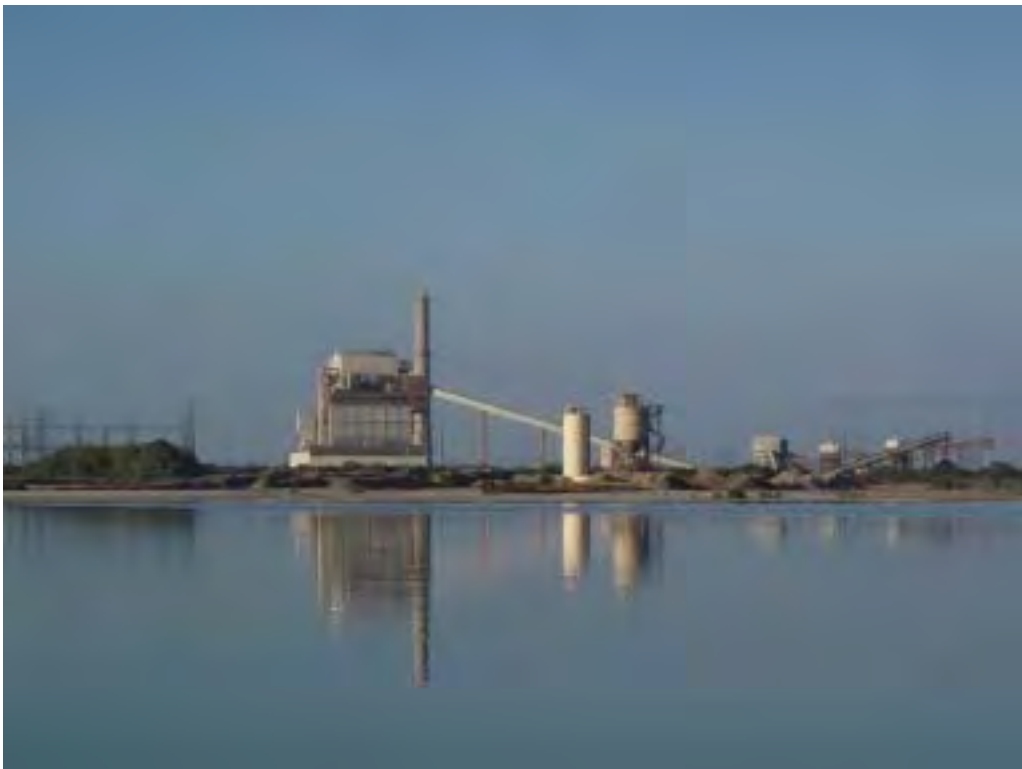
Photo No. 60: Primary Ash Pond – Close up power plant, looking south from the north embankment.

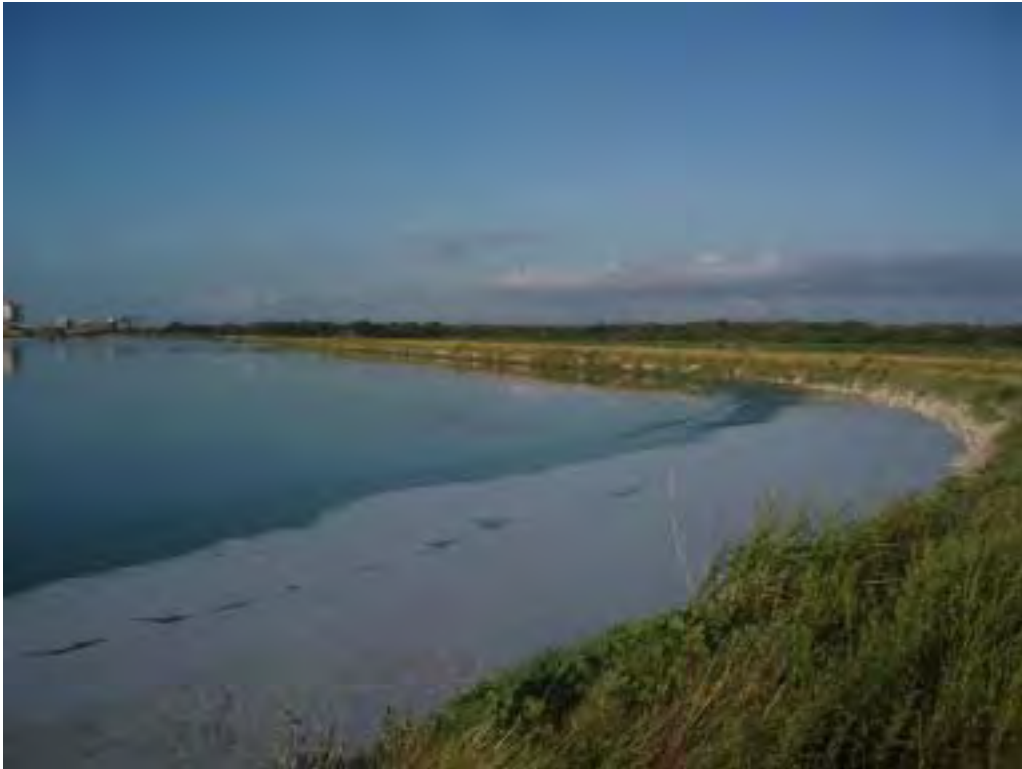
Photo No. 61: Primary Ash Pond – Overview of west embankment interior slope, looking southwest from the north embankment.

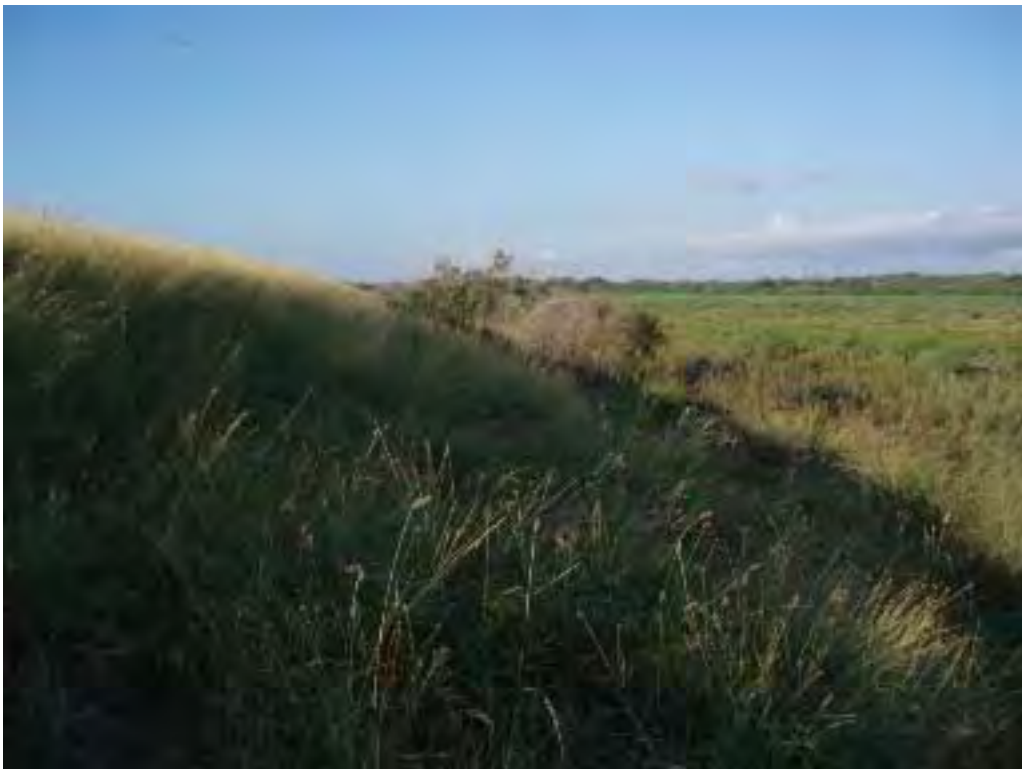
The north, west, and east embankments were generally covered with grass and small brush approximately 24 to 48 inches tall. On the north and west embankments there were 6- to 12-inch-diameter mesquite trees on the slope (Photos 52, 62, and 66). Smaller mesquite trees, 1 to 2 inch inches in diameter were observed on the east embankment. On the north embankment, areas of well established vegetation were observed (Photo 53). The southwest, south, and southeast embankments were covered with grass approximately 6 to 12 inches tall.

Photo No. 62: Primary Ash Pond – West embankment exterior slope, looking south.

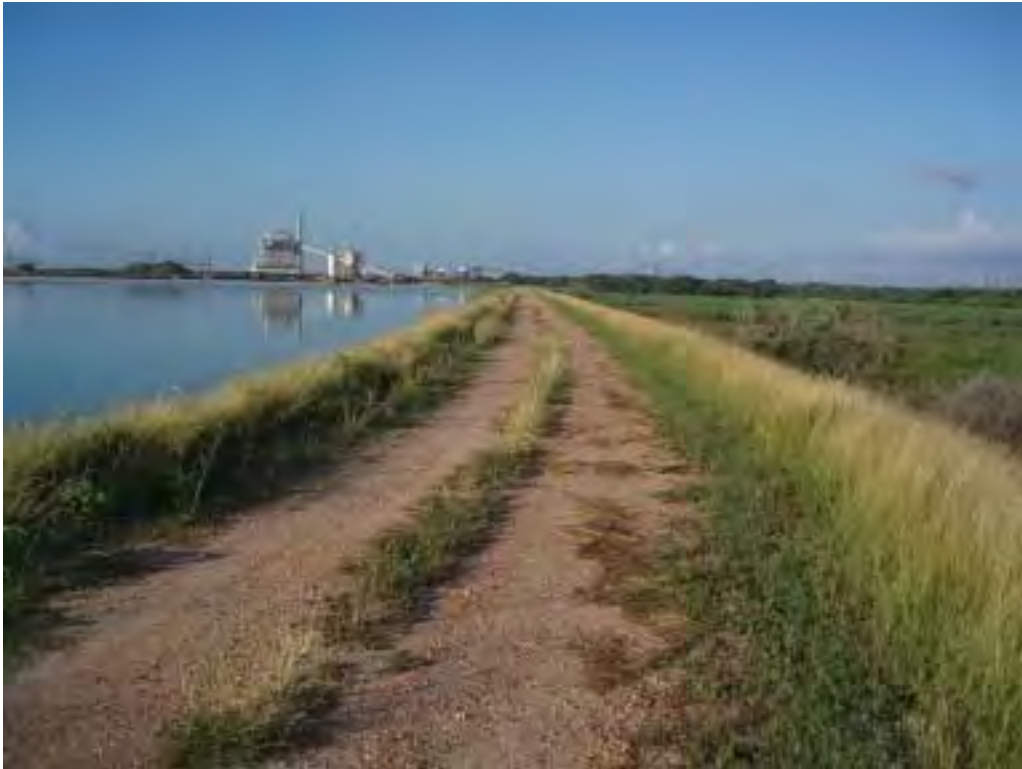
Photo No. 63: Primary Ash Pond – West embankment crest, looking south.

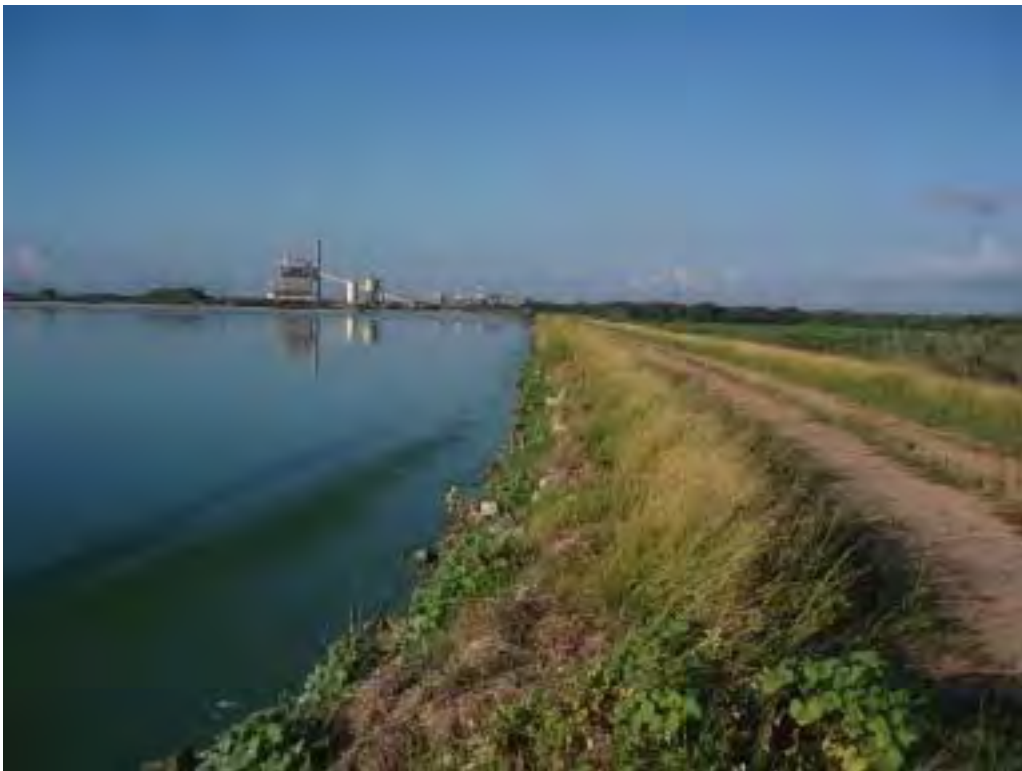
Photo No. 64: Primary Ash Pond – West embankment interior slope, looking south.

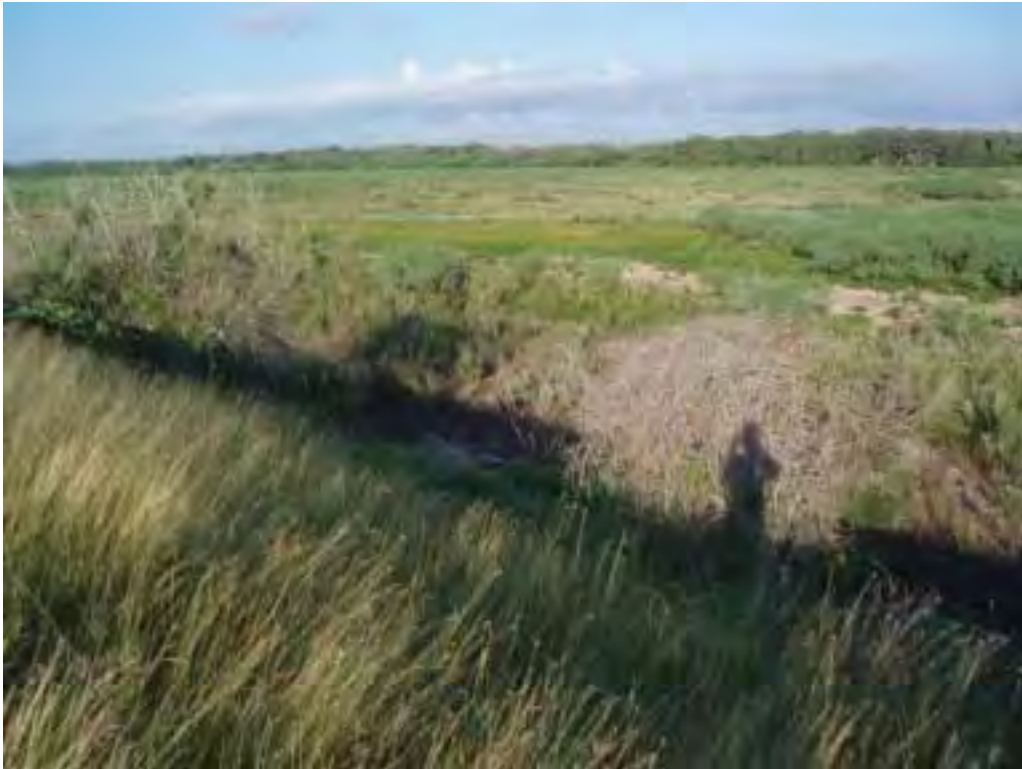
Photo No. 65: Primary Ash Pond – West embankment exterior slope, looking southwest at bare spot at toe and two mesquite trees. Tree diameters range from 6 to 12 inches.

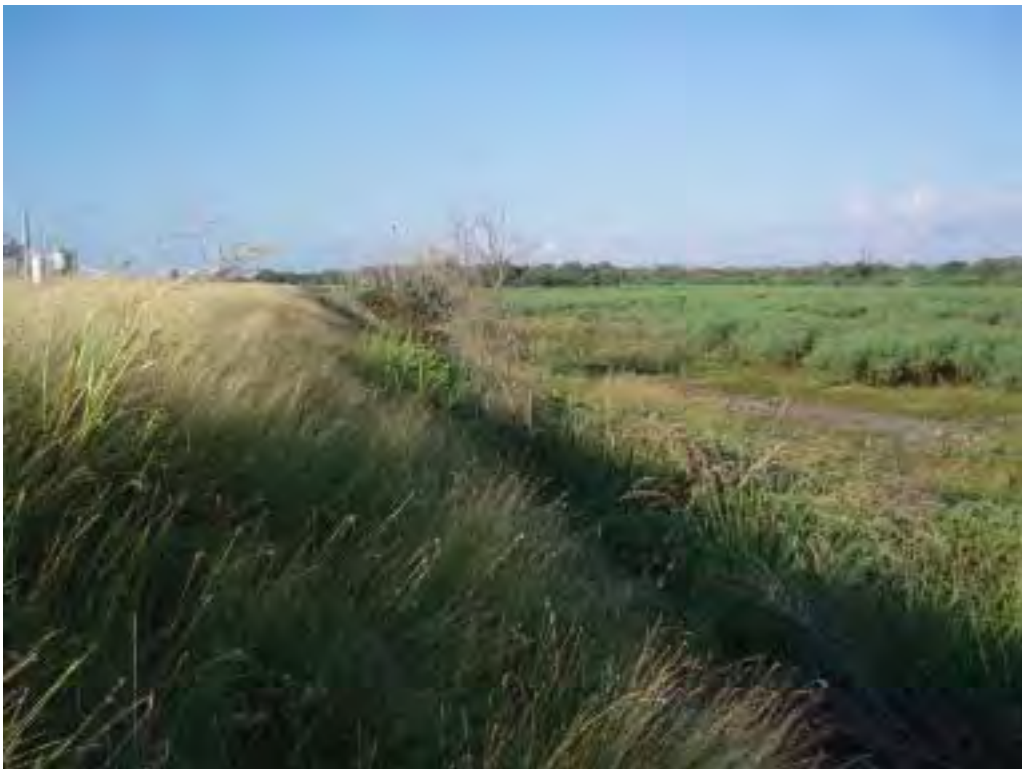
Photo No. 66: Primary Ash Pond – West embankment exterior slope, looking south at thick vegetation and mesquite trees.

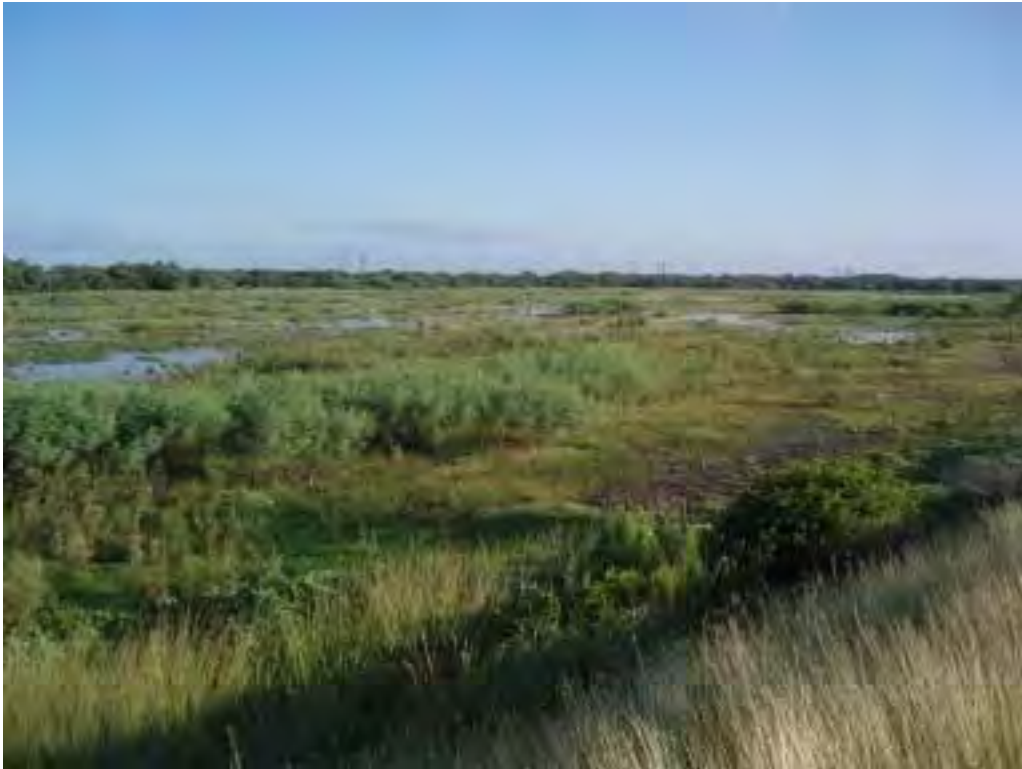
Photo No. 67: Primary Ash Pond – West embankment, looking northwest at Evaporation Pond.

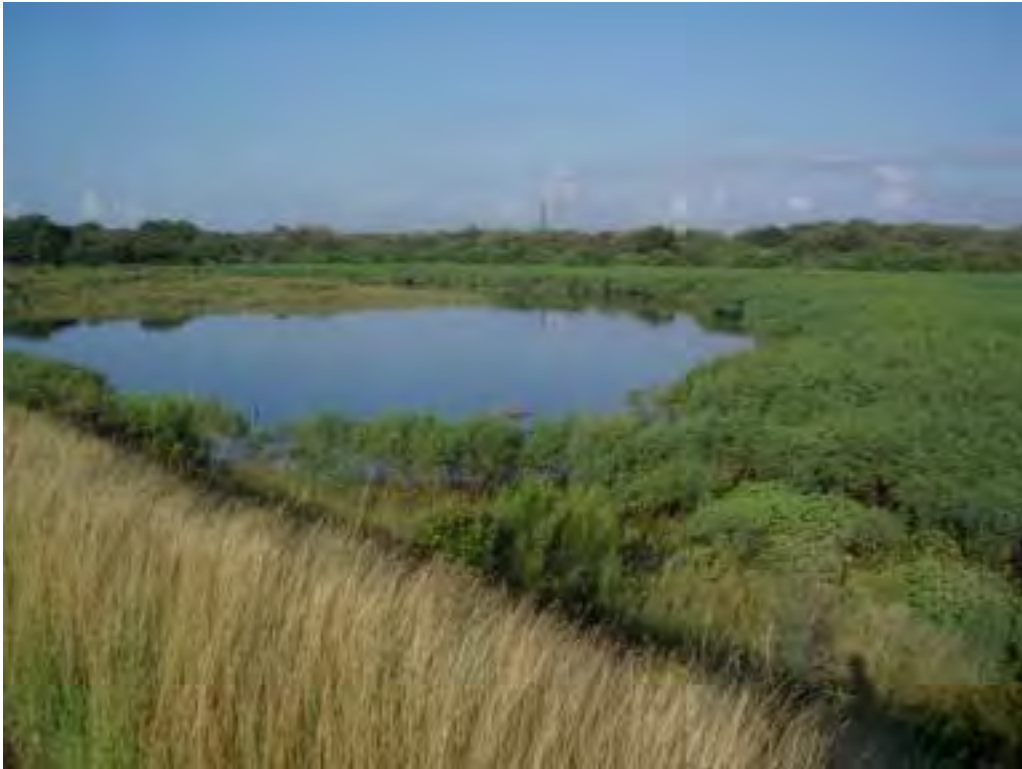
Photo No. 69: Primary Ash Pond – West embankment, looking southwest at Evaporation Pond.

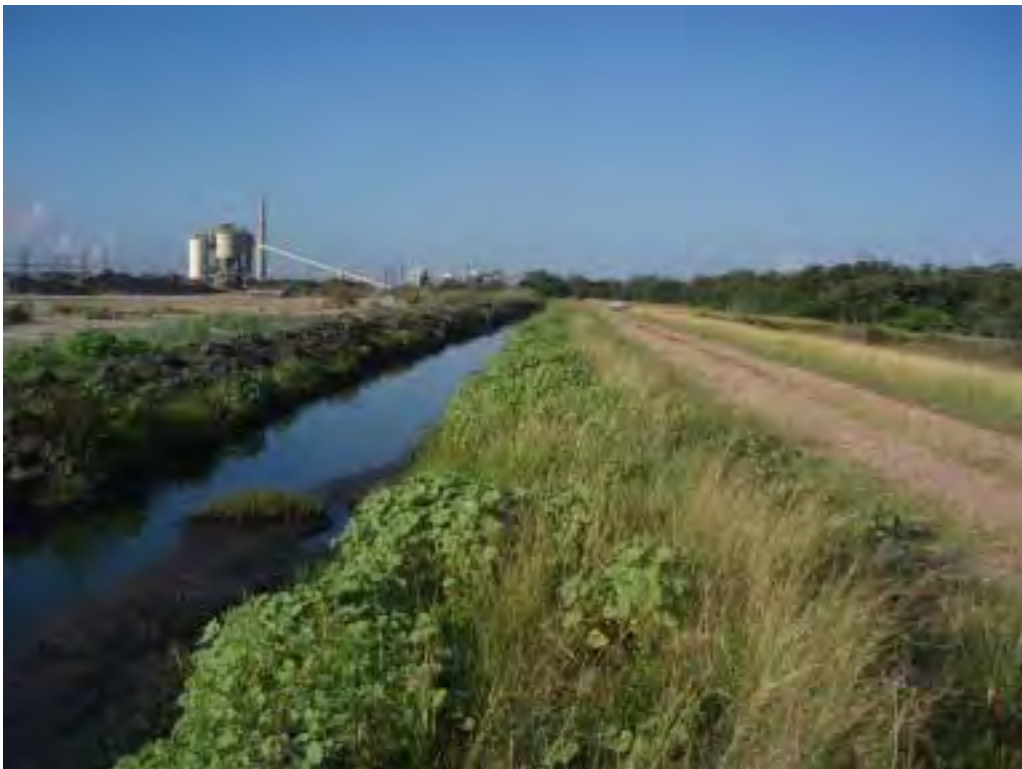
Photo No. 70: Primary Ash Pond – West embankment interior slope, looking south at surface water drainage ditch.

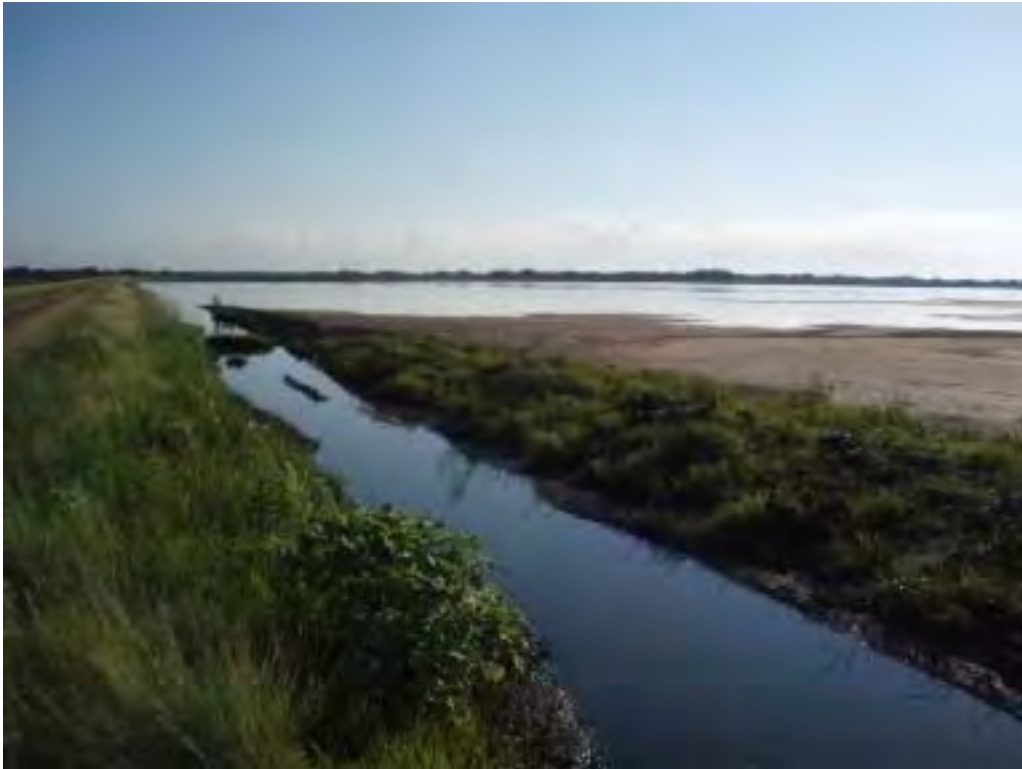
Photo No. 71: Primary Ash Pond – Interior slope looking northeast at impoundment and surface water drainage ditch.

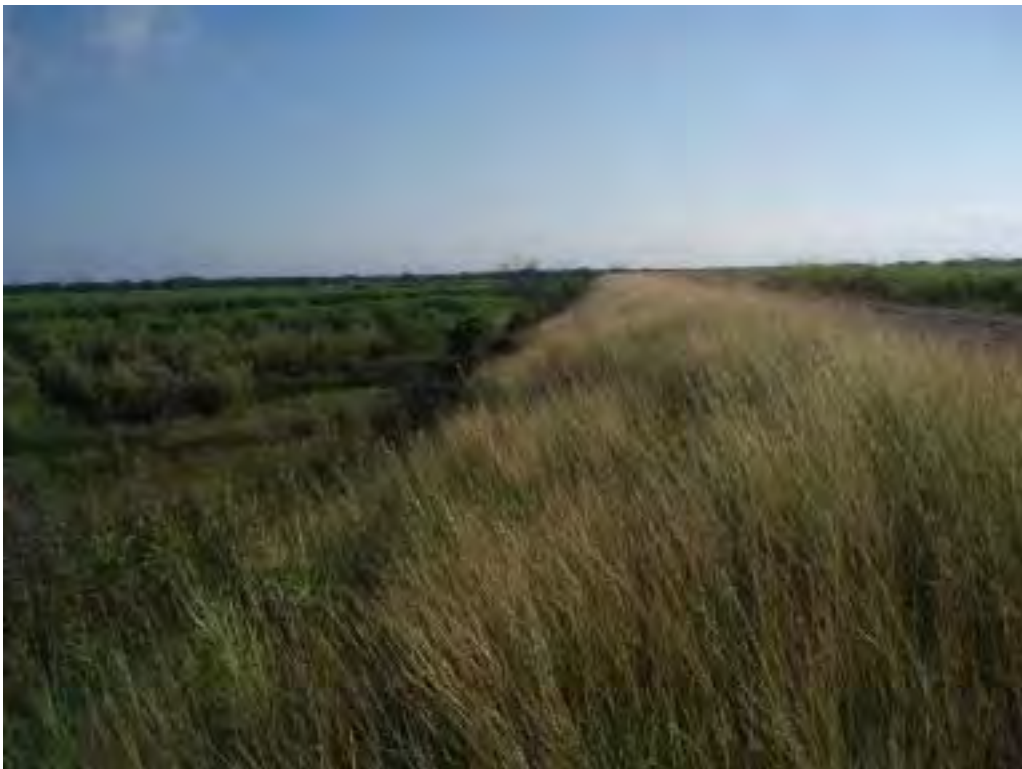
Photo No. 72: Primary Ash Pond – West embankment exterior slope, looking northeast.

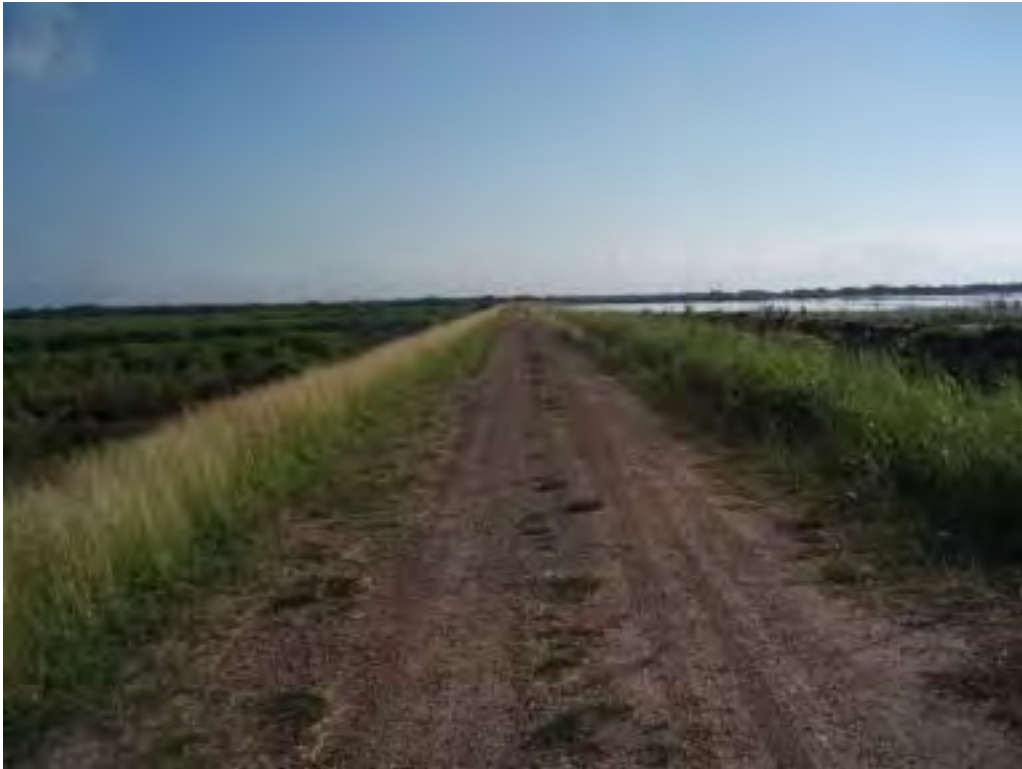
Photo No. 73: Primary Ash Pond – West embankment crest, looking northeast.

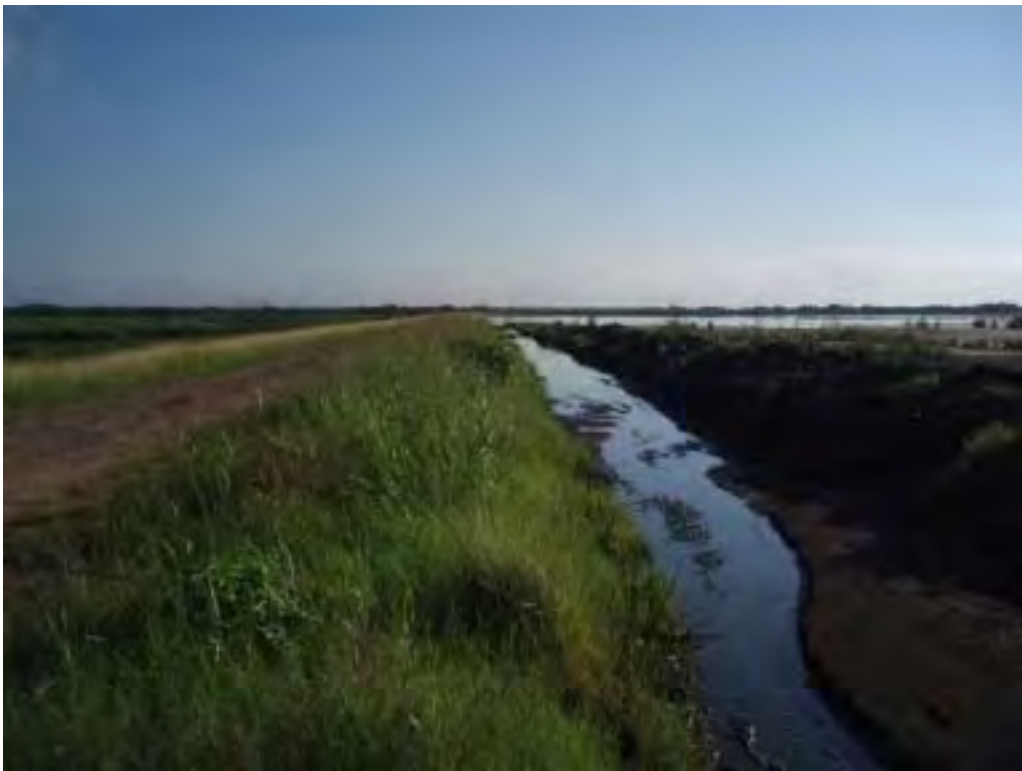
Photo No. 74: Primary Ash Pond – West embankment interior slope, looking northeast.

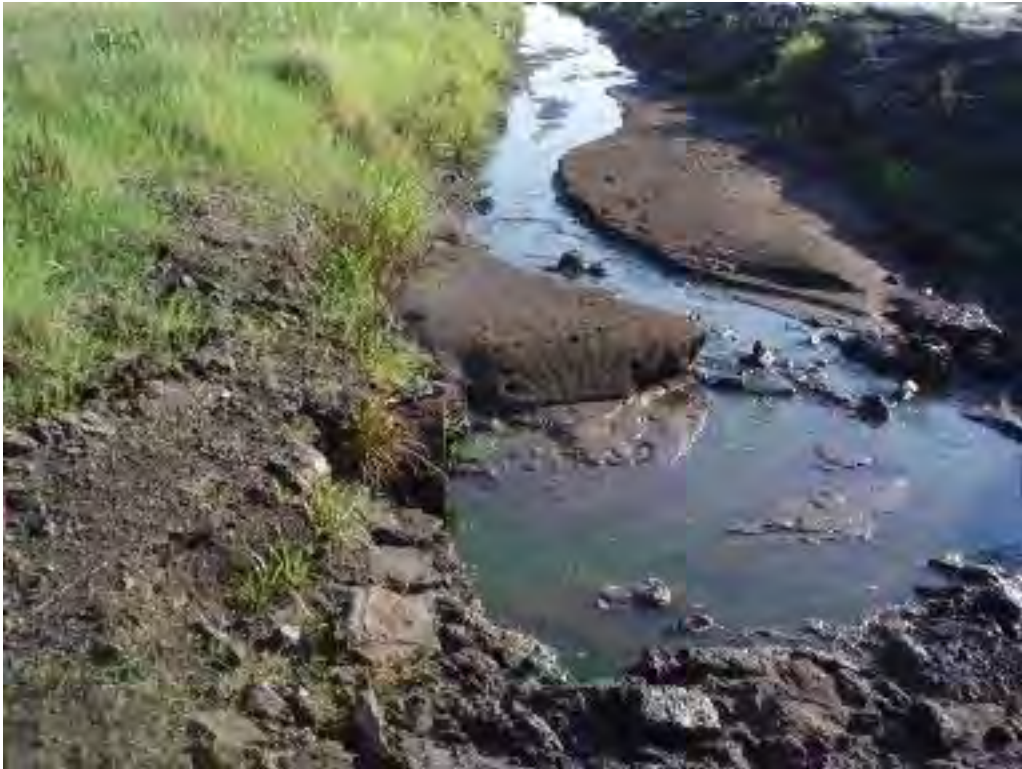
During the site visit, four sets of sluice pipes were observed. The two CCW sluice pipes on the southeast and south embankment appeared to be in fair condition (Photos 80, 81, 83, and 84). The boiler area sump sluice pipe on the west embankment and the demineralizer effluent sluice pipe on the southeast embankment also appeared to be in fair condition (Photos 75 and 85). No seepage was observed where the pipes penetrated through the embankment.

Photo No. 75: Primary Ash Pond – West embankment interior slope, looking at 20-inch-diameter DI surface water decant pipe.
